KENTUCKY HISTORIC RESOURCES
INDIVIDUAL SURVEY FORM
(KHC 2002-1)

COUNTY Lewis
RESOURCE # Lw-69
RELATED GROUP #
EVALUATION S
SHPO EVALUATION S
DESTROYED

1. NAME OF RESOURCE (how determined): 9/ House

Northwest corner Garrad Road and KY. 10, south of the AA Highway
Tollesboro, KY. 41189

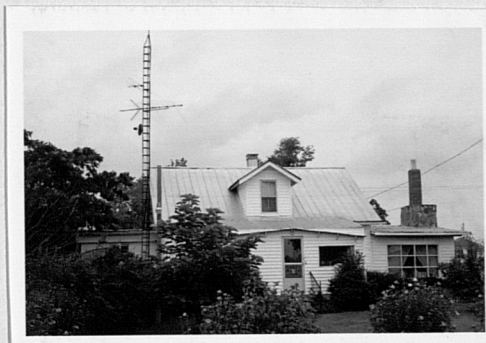
This property is a c. 1920-1925 frame Cape Cod-style residence clad in vinyl siding. The house has an enclosed front porch and/or later one-story room addition on the façade, and two later c. 1950 additions on either side. Windows are a mix of picture windows, casement, and double-hung sash, either in wood or aluminum. The property has a very large stone and brick chimney on the eastern addition, and a small stuccoed chimney on the main house. The entire structure has a standing-seam metal roof. A gabled roof dormer is on the front façade; the single window is a 2/2 double-hung sash, and the entire dormer is clad in vinyl. The foundation was obscured by brush and not easily discernible; it may be stuccoed.
